CAPE COD
COMMISSION

2009 Transportation Safety Report

May 2010

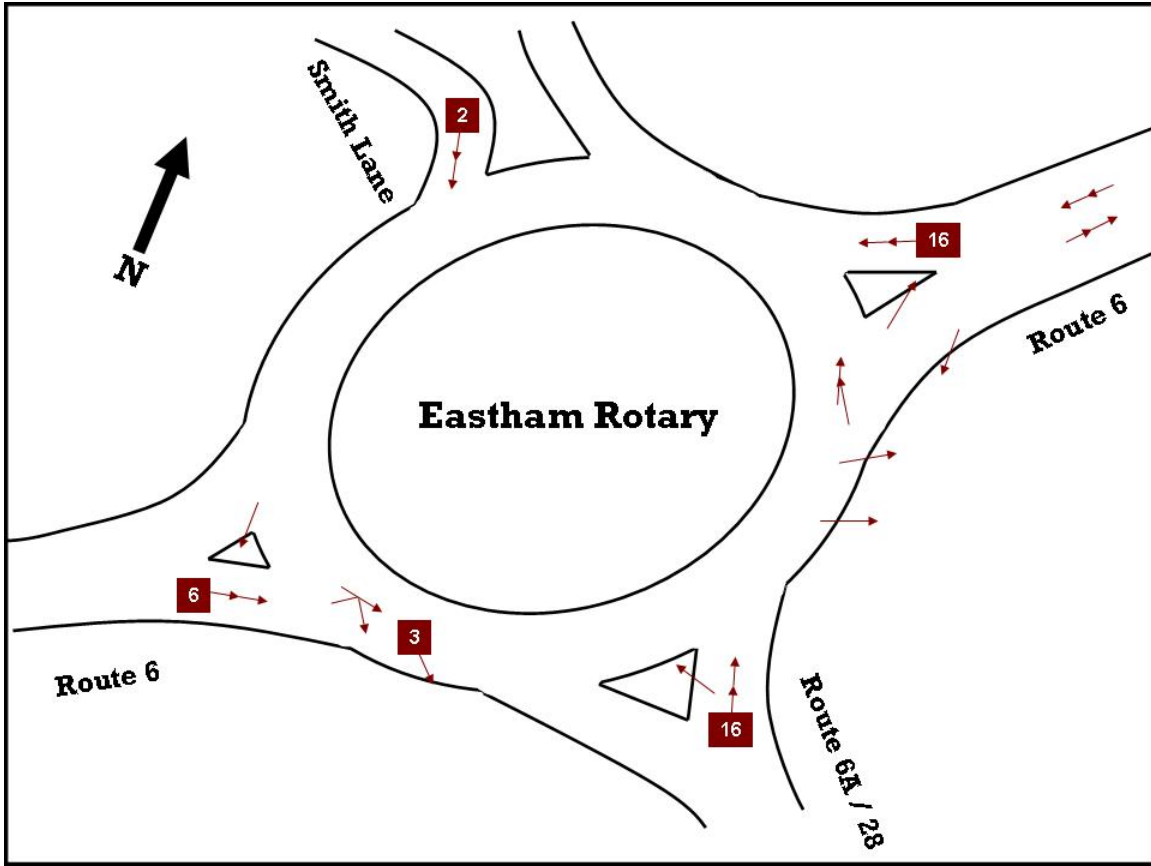
Figure 3 – Crash Diagram: Eastham Rotary, 2006-2009

The majority of accidents, 42 of 53, were rear-ending incidents (see Figure 3). All but two of those rear-ending crashes occurred at an on-ramp to the rotary. In most scenarios, the at-fault driver admitted to a lack of attention before hitting the rear of the car ahead of them. The crashes occurred at two of the on-ramps more than the other two. Route 6A/28 northbound and Route 6 westbound from Eastham had 16 rear-ending accidents each during this time period. Route 6 eastbound and Smith Lane southbound had a total of eight rear-ending incidents.

During this time period, the free-standing post located in the island east of the rotary that flashes a yellow, blinking light was hit at least twice.

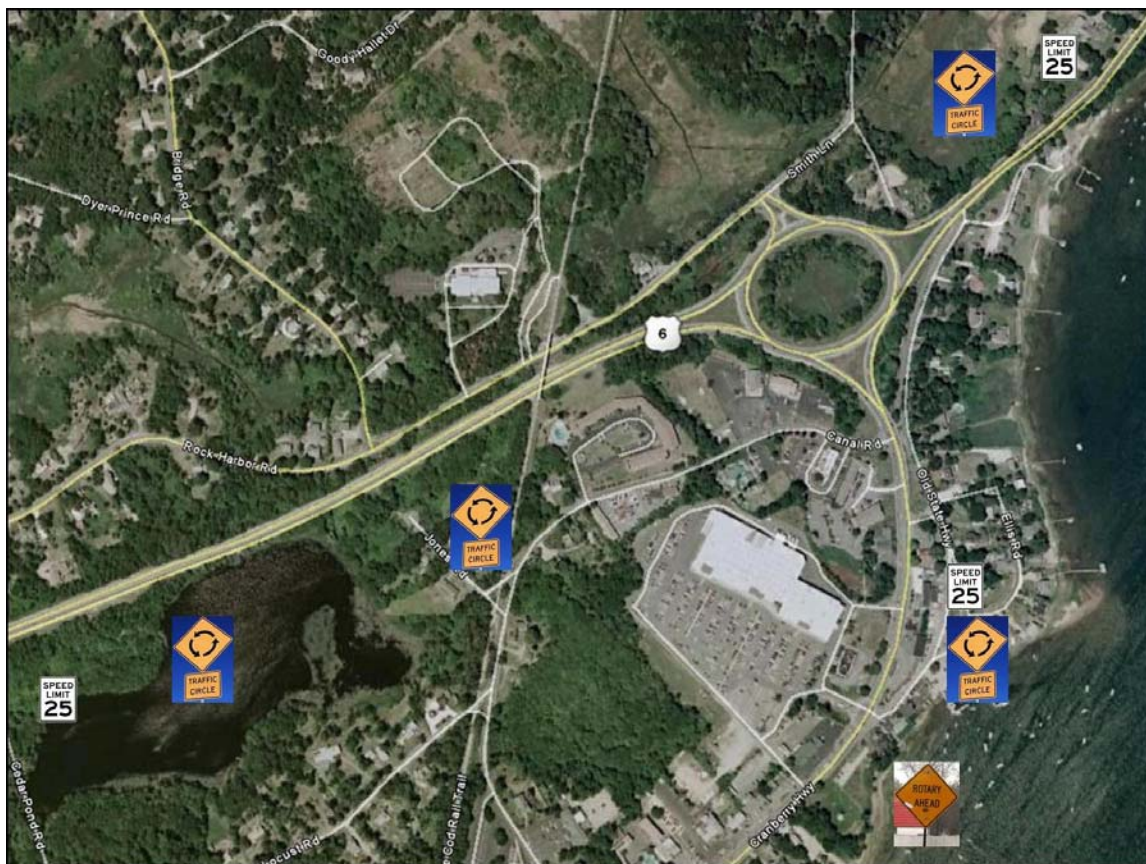
Figure 7 – Eastham Rotary Signage

As seen in the crash diagram (Figure 3), rear-end crashes of vehicles entering the rotary are more prevalent at the Route 6A/28 and Route 6 from Eastham approaches. As part of the investigation as to why Route 6 from Orleans eastbound has fewer crashes, this report identifies the type of signage used to warn motorists of the approaching rotary and their location. As is expected for a road with higher speeds, warning signs for Route 6 eastbound begin more than half a mile prior to the rotary (as opposed to 0.18 miles for Route 6A/28 and 0.19 miles for Route 6 from Eastham). Route 6 eastbound has three signs cautioning of the rotary, starting with a sign indicating a reduction in the speed limit to 25 miles per hour, then two consecutive signs with a diagram labeled as “traffic circle.” Route 6A/28 also has three signs, while Route 6 westbound has two, and Smith Lane has none. For sign locations, see Figure 7.

The first recommendation of this study is for the towns of Eastham and Orleans evaluate the types of signage used to caution motorists of the upcoming rotary and the placement of those signs. There is a large disparity between the accidents on two of the approaches as compared to the other two, and driver awareness is likely related. It is recommended that the 'Rotary' signs currently placed on the rotary's island be moved leftwards. Each approach has this sign facing it from the island, but the sign is not visible until you are within two car lengths of the merge. Shifting the signs left would allow them to be visible from a farther distance.

On both the Route 6A/28 and Route 6 from Eastham approaches, where rear-ending crashes were most prevalent, most drivers cited their lack of attention as the contributing factor to the crash. This study recommends that the towns of Eastham and Orleans investigate the potential use of grooved pavement as a means of alerting drivers to the upcoming rotary. Driving over grooved pavement creates a sound that can be disturbing to residents and nearby businesses, so appropriate siting is essential.

Route 6 has two travel lanes from Eastham towards the rotary until there is a lane-drop about a half mile before the rotary. Town officials have shown concern that the sign indicating the lane-drop may be presented to drivers too late. This study recommends an evaluation of signage regarding the reduction from two lanes to one.

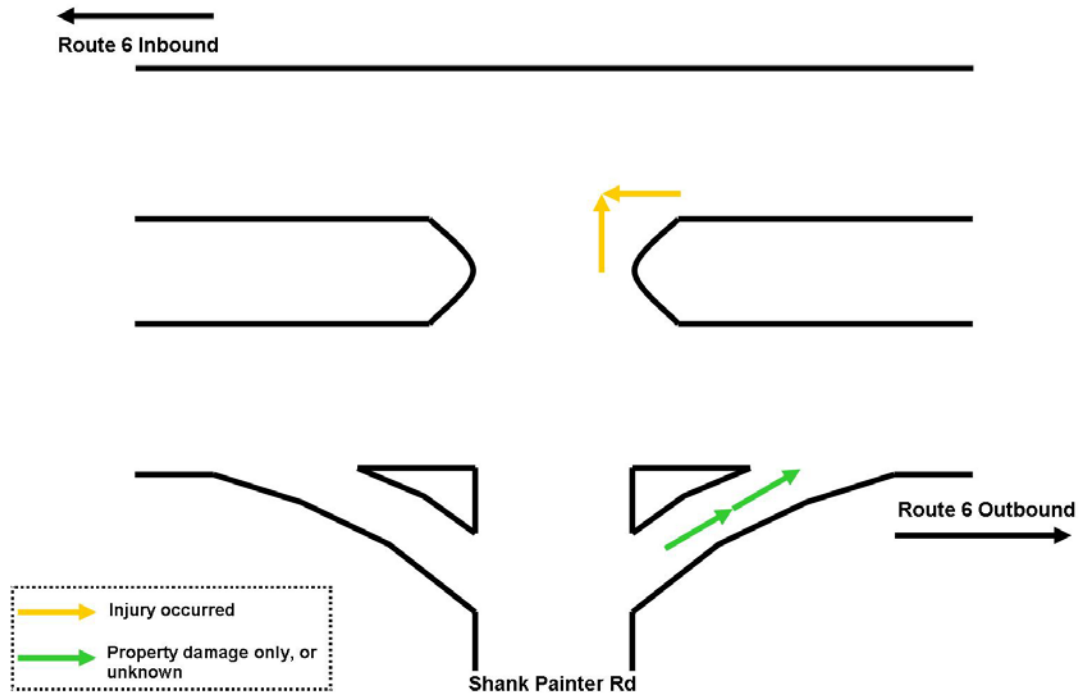
Figure 20 – Crash Diagram: Route 6 and Shank Painter Road

Date	Manner	# Vehicles	Severity	EPDO ¹
07/31/2006	Rear-end	2	Property damage only or unknown	1
07/05/2008	Angle	2	Injury	5
08/13/2008	N/A	N/A	N/A	1*
				7

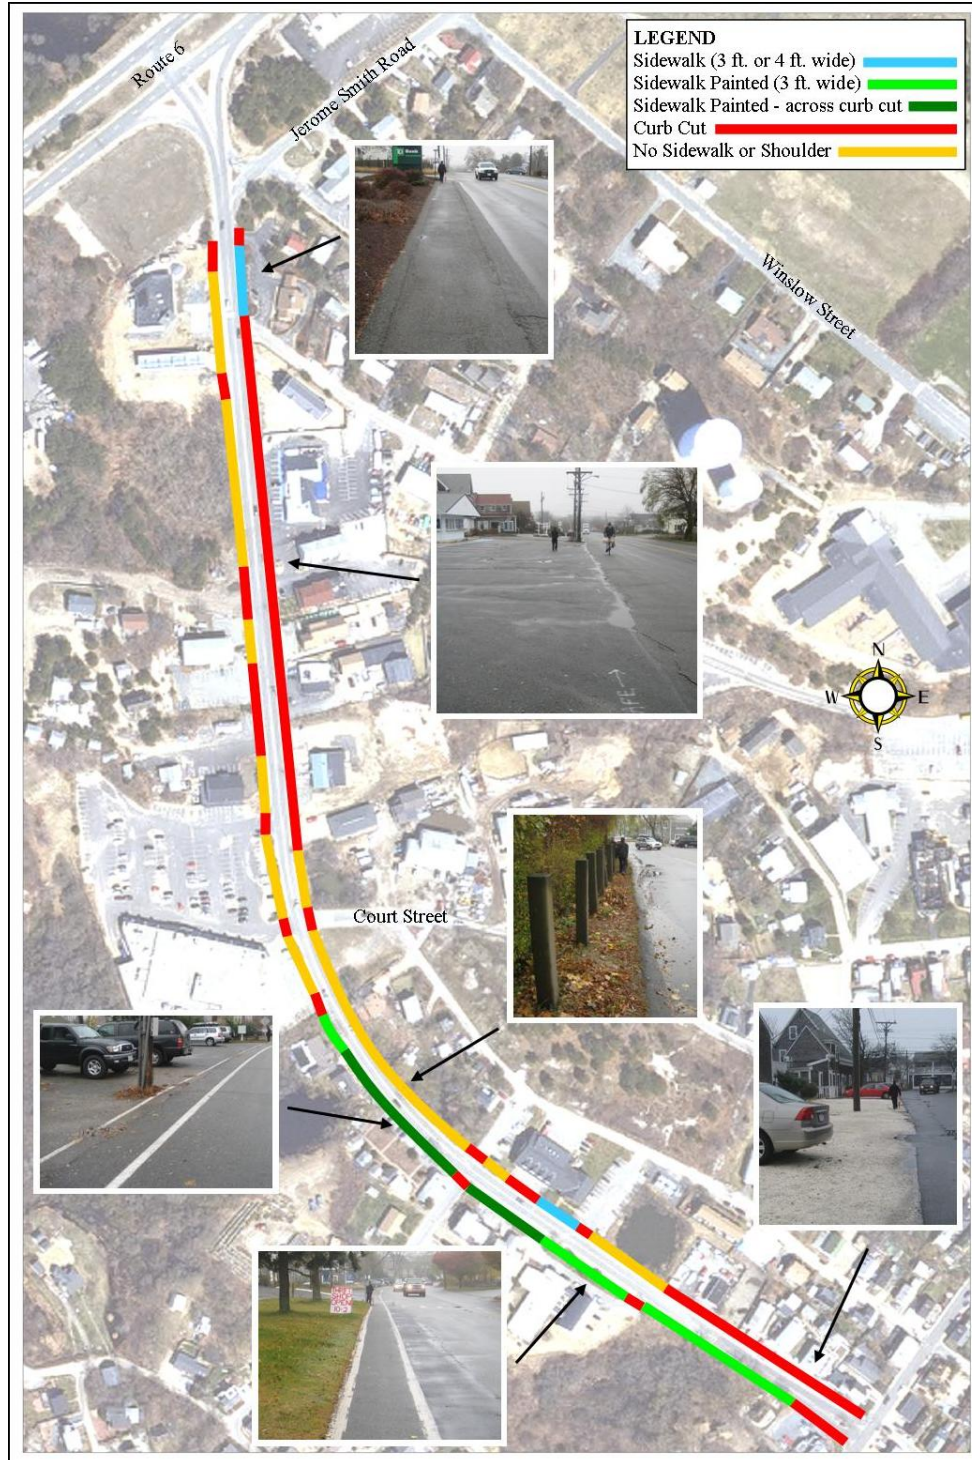
Figure 25 – Shank Painter Road: Sidewalk Inventory

A survey conducted by the Cape Cod Commission of Shank Painter Road's bicycle and pedestrian facilities shows inadequate connectivity on the corridor. The road's east side has about 180 feet of sidewalk separated from the road, compared to 1,420 feet of curb cuts (most of which are vast unrestricted segments of

This study recommends that a sidewalk plan be created for Shank Painter Road, to create an organized, well-connected pedestrian path and bicycle route. The town may consider pursuing enhancement funds from the Transportation Improvement Program (TIP).

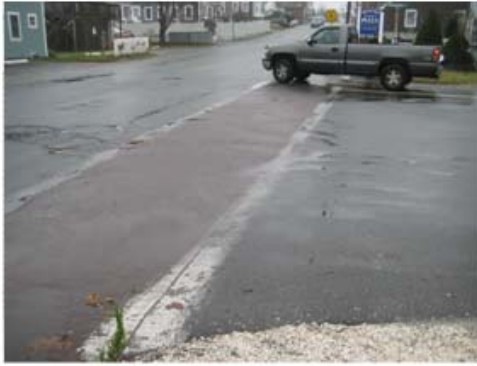
Faded crosswalk at the southern end of Shank Painter Road, looking westbound along Bradford Street.

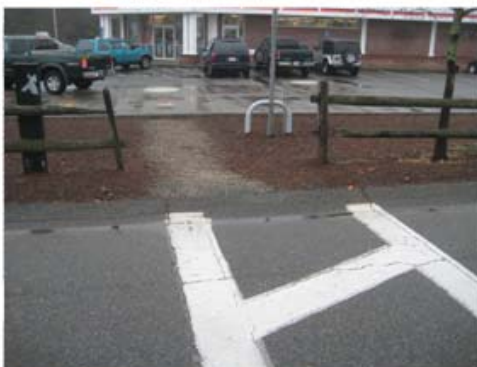
Crosswalk on the north end of Shank Painter Road, looking westbound at the Cumberland Farms parking lot. The path from the sidewalk beside TD Bank across to Cumberland Farms is not handicap accessible, requiring patrons to traverse an off-road path then overcome a curb onto the lot.

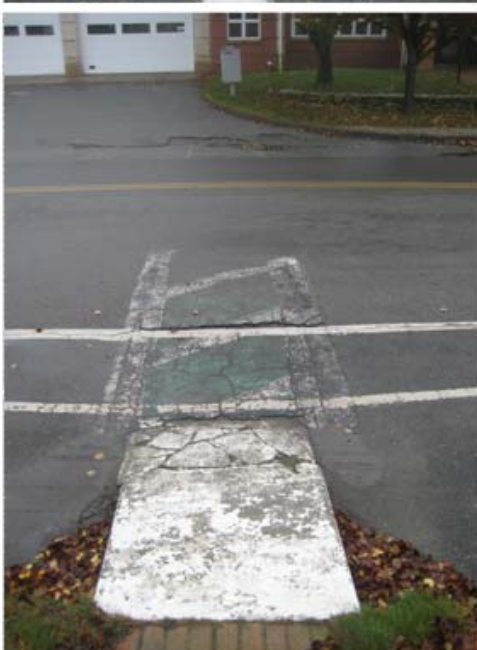
Faded crosswalk between the Police Station and Fire Station.
